DEVELOPMENT OF IMPROVED LACV-30 PROPELLER BLADE COATINGS  
FOR PROTECTION AGAINST SAND AND RAIN EROSION AND MARINE  
ENVIRONMENT CORROSION

Glenn A. Malone  
Bell Aerospace Textron  
Post Office Box 1  
Buffalo, New York 14240

10 May 1983

Final Report for period 4 January 1982 - 4 March 1983

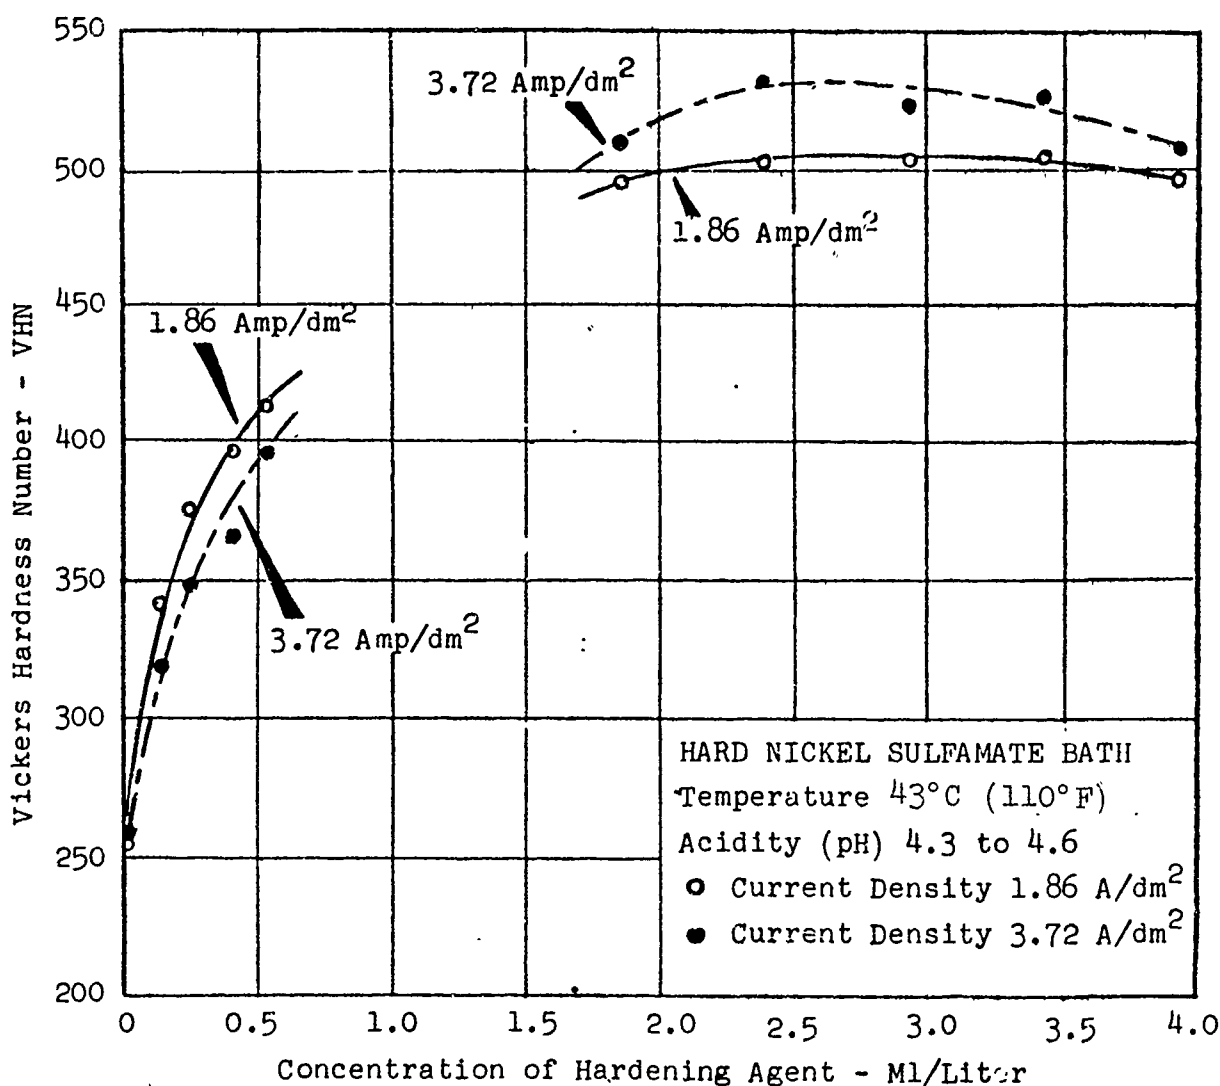
Figure 2. Effects of Current Density and Hardening Agent (SNHA) Concentration on Vickers Hardness of EDHN.

Working with electrolytes containing 0.13 to 0.53 ml/l of SNHA, the entire range of VHN's sought for the program could be produced as shown in Table 8. These results have been plotted, Figure 2, to show the effects of current density and SNHA concentration on VHN. The most suitable SNHA concentration appears to be 0.50 to 0.75 ml/l for producing VHN's in the range of 400 to 450. Since actual propeller blades have been observed to undergo as much as five percent creep during their service life, it is essential that the EDHN coatings have adequate ductility. Suitable ductility has been confirmed by the elongation results reported in Table 8.

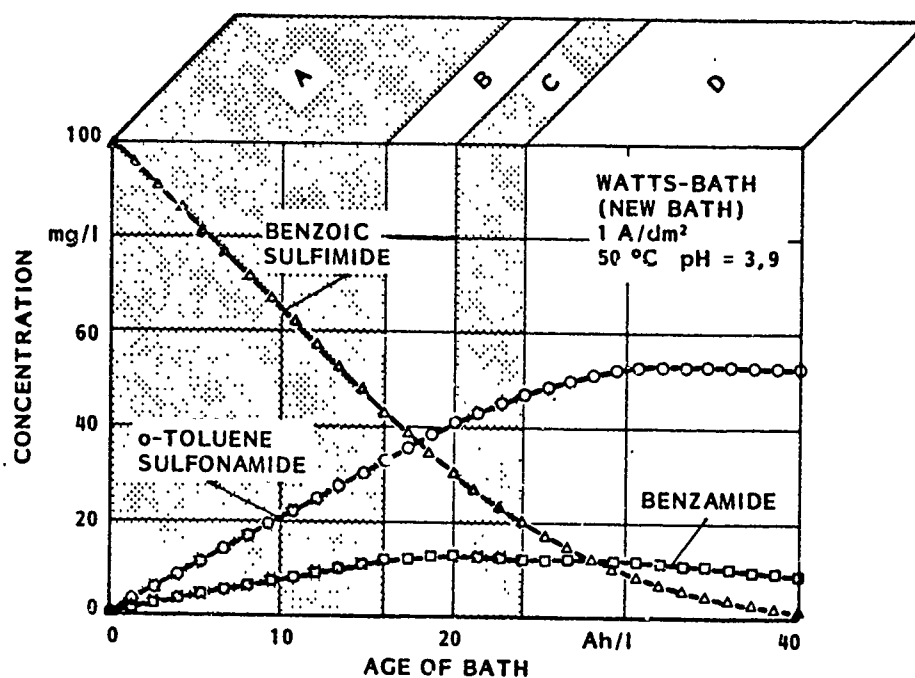
Figure 3. Decomposition of Benzoic Sulfimide during Electrolysis.

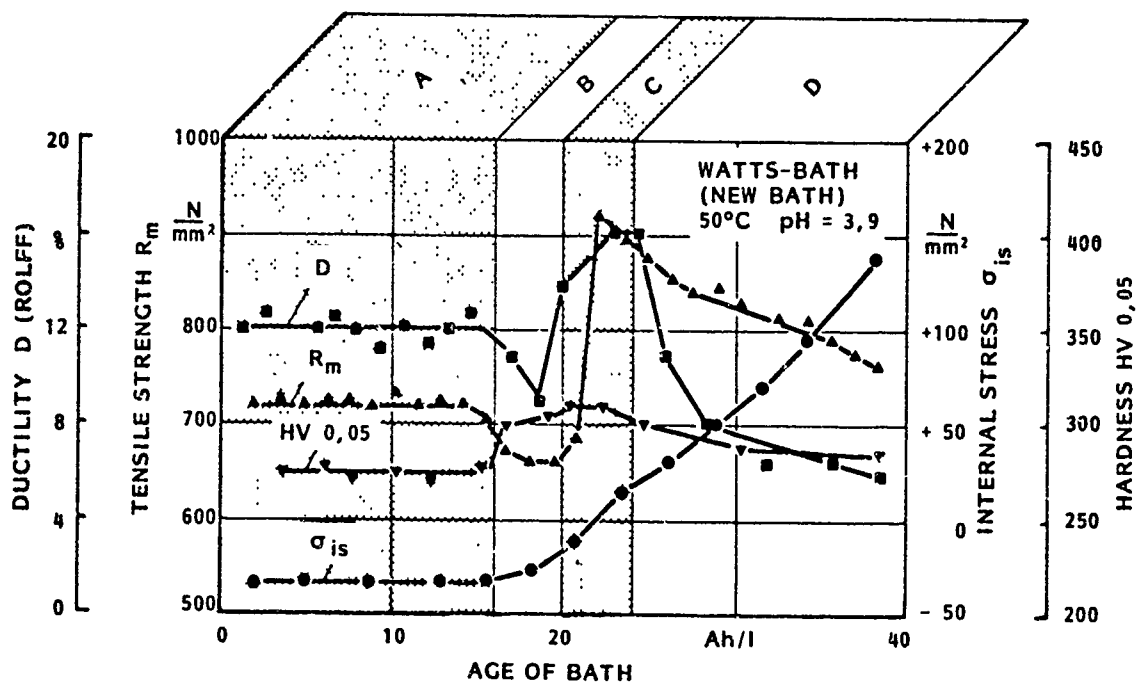
Figure 4. Changing of the Mechanical Properties during Electrolysis.

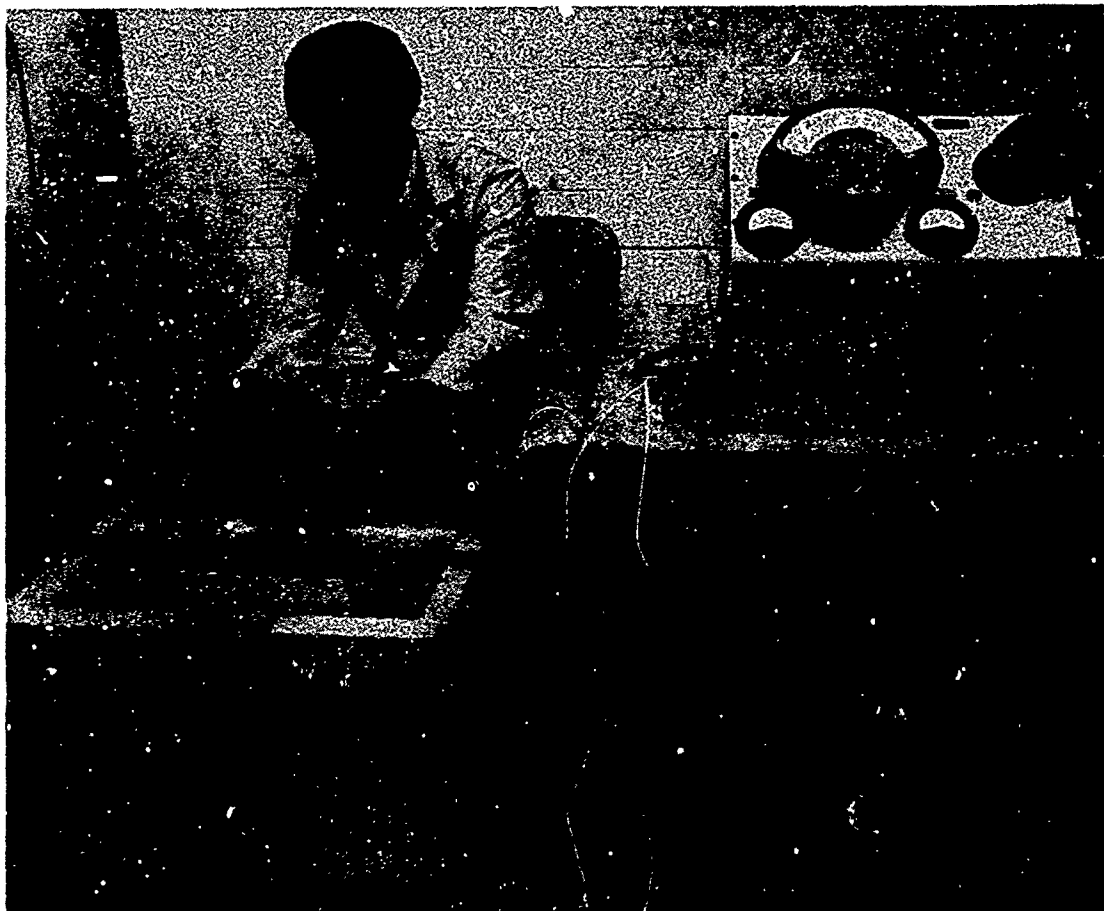
Figure 6. Dilute Phosphoric Anodizing Facility

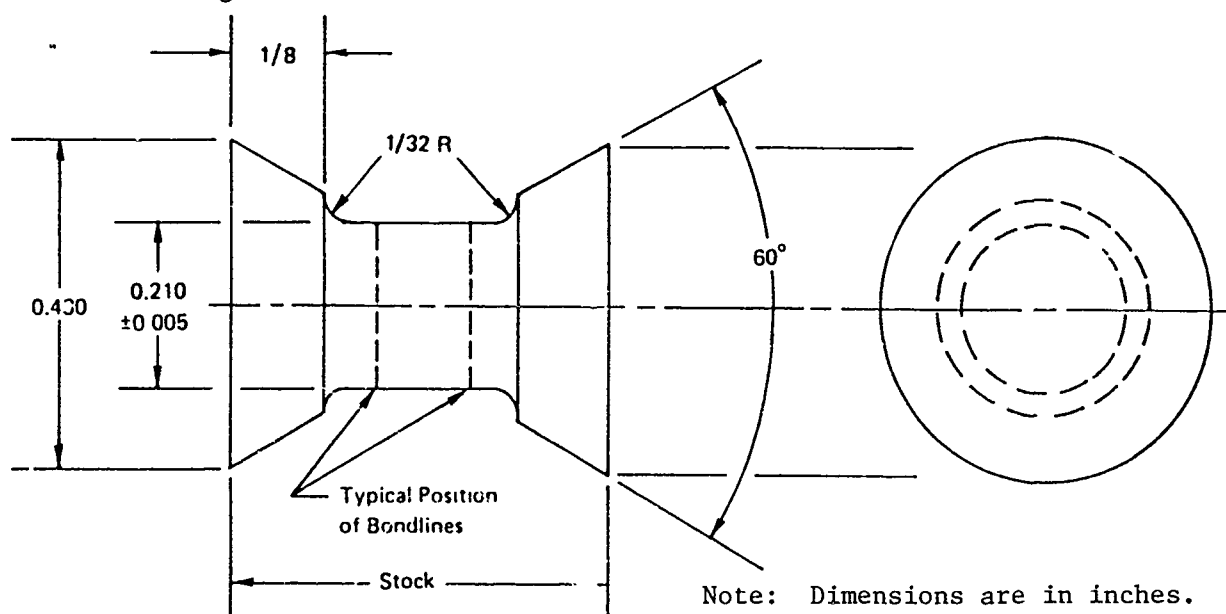
Figure 8. Conical Head Bond Strength Test Specimen

Figure 8 depicts the configuration of the conical head test specimens after machining.

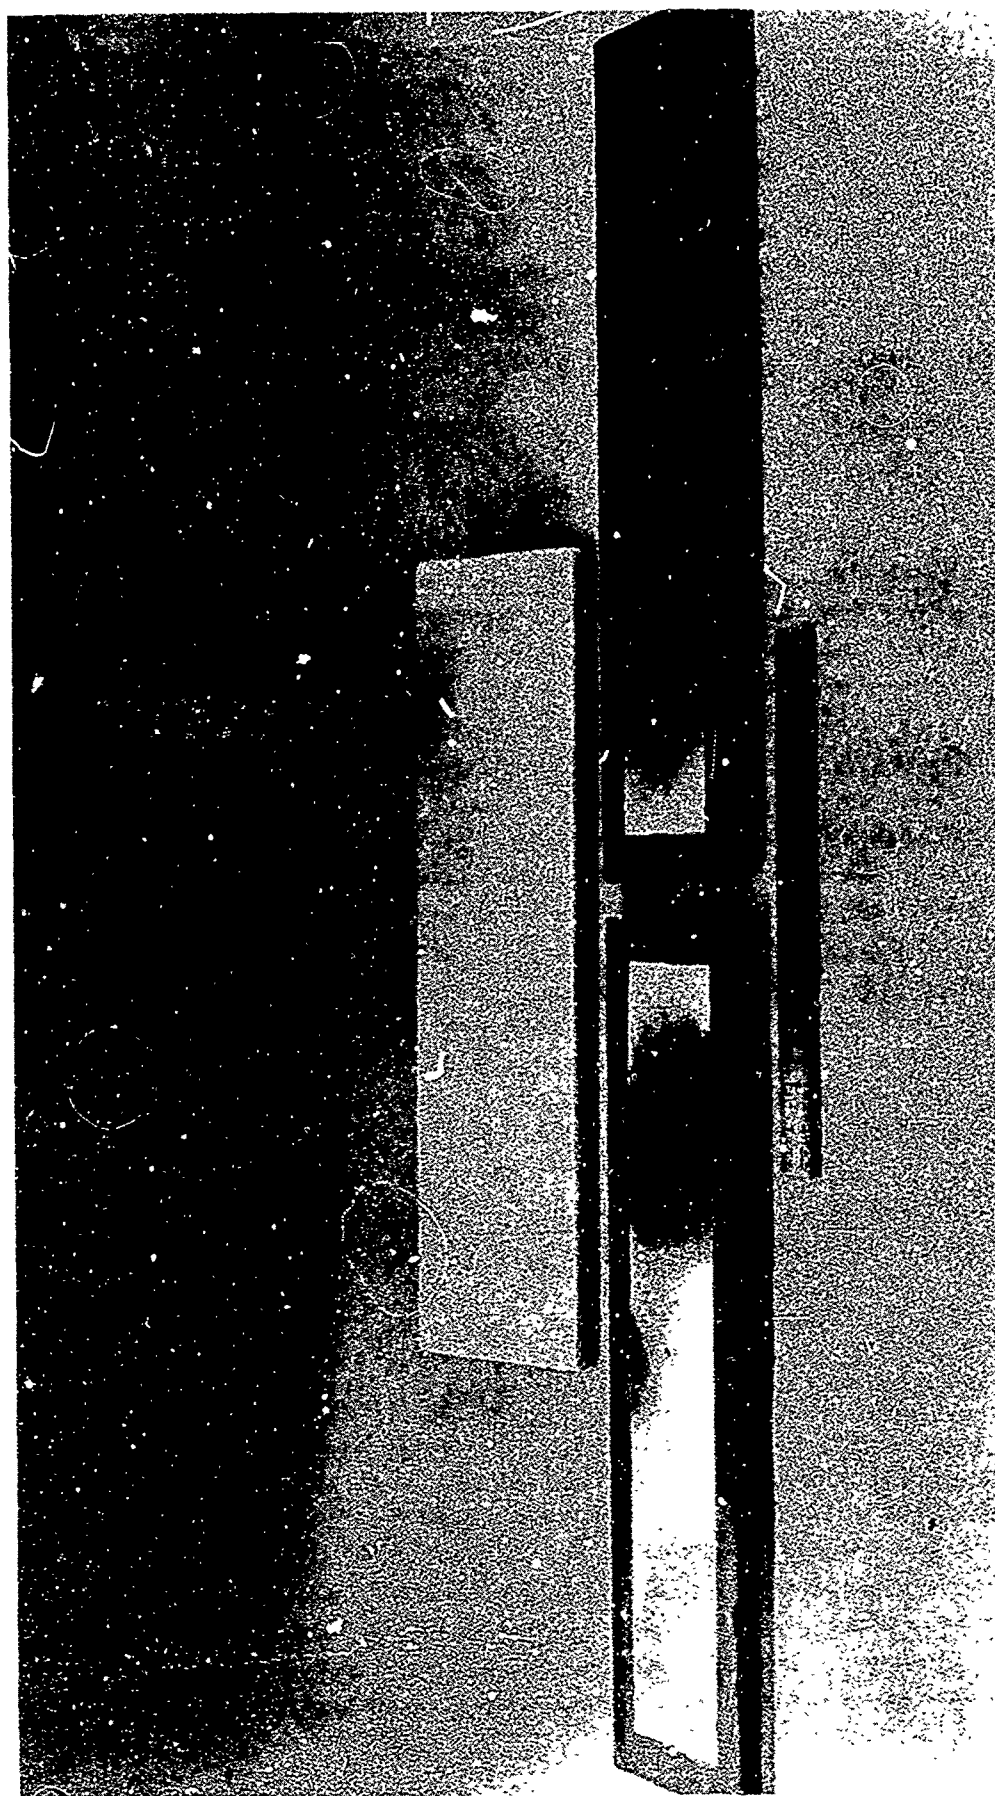
Figure 9. Corrosion Study Panels

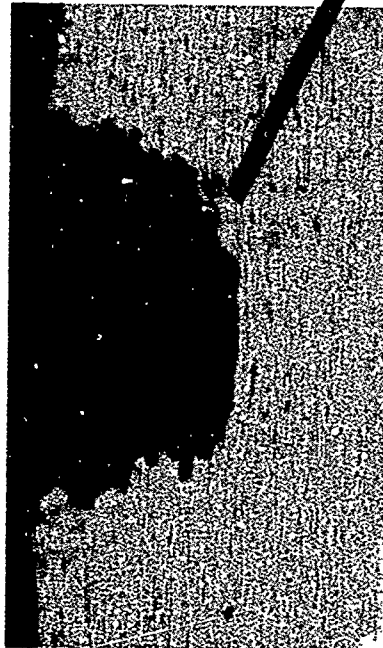
Panel No. 1

Figure 10. Illustrations of Salt Fog Corrosion Performance of Uncoated

<u>Panel Appearance After Salt Fog, Rinse, and Drying</u>	<u>Metallographic Examination Results</u>	<u>Rating</u>
Both panels were severely corroded and had an etched appearance. Refer to Figure 10.	Moderate corrosion on all surfaces.	Poor
Both panels exhibited localized corrosion at spots where the nickel coating was punctured or contained pinhole porosity. Deep pitting of the Al 7075 was noted - with displacement copper plating from the dissolved Al alloy. Refer to Figure 11.	Corroded only where coating was porous or discontinuous; pitted badly in these areas.	Fair
Both panels showed few traces of corrosion. The minute salts present appeared to be from pinholes present in the thin hard nickel layer. No penetration to Al 7075 was evident. Refer to Figure 12.	Excellent performance in all respects. Noted traces of nickel salts where hard nickel was possibly porous.	Excellent
Each panel exhibited significant blistering believed to have originated at the zinc-anodized interface. The corrosion salts were white (indicative of zinc) with some light green salts also present (probably nickel). Refer to Figure 13.	Blistered very severely due to lack of adhesion of zinc to anodic film.	Poor to Bad

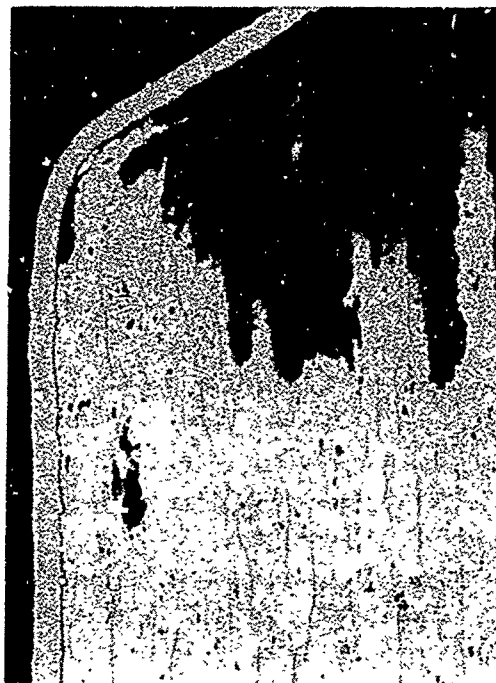
Panel No. 4

Corrosion pit in Aluminum 7075-T651  
(above). Enlarged view showing the  
undermining of the hard nickel coat  
(below).

Figure 11. Illustrations of Salt Fog Corrosion Performance of Bondal Zincated and  
Hard Nickel Plated Aluminum 7075-T651 Test Specimens

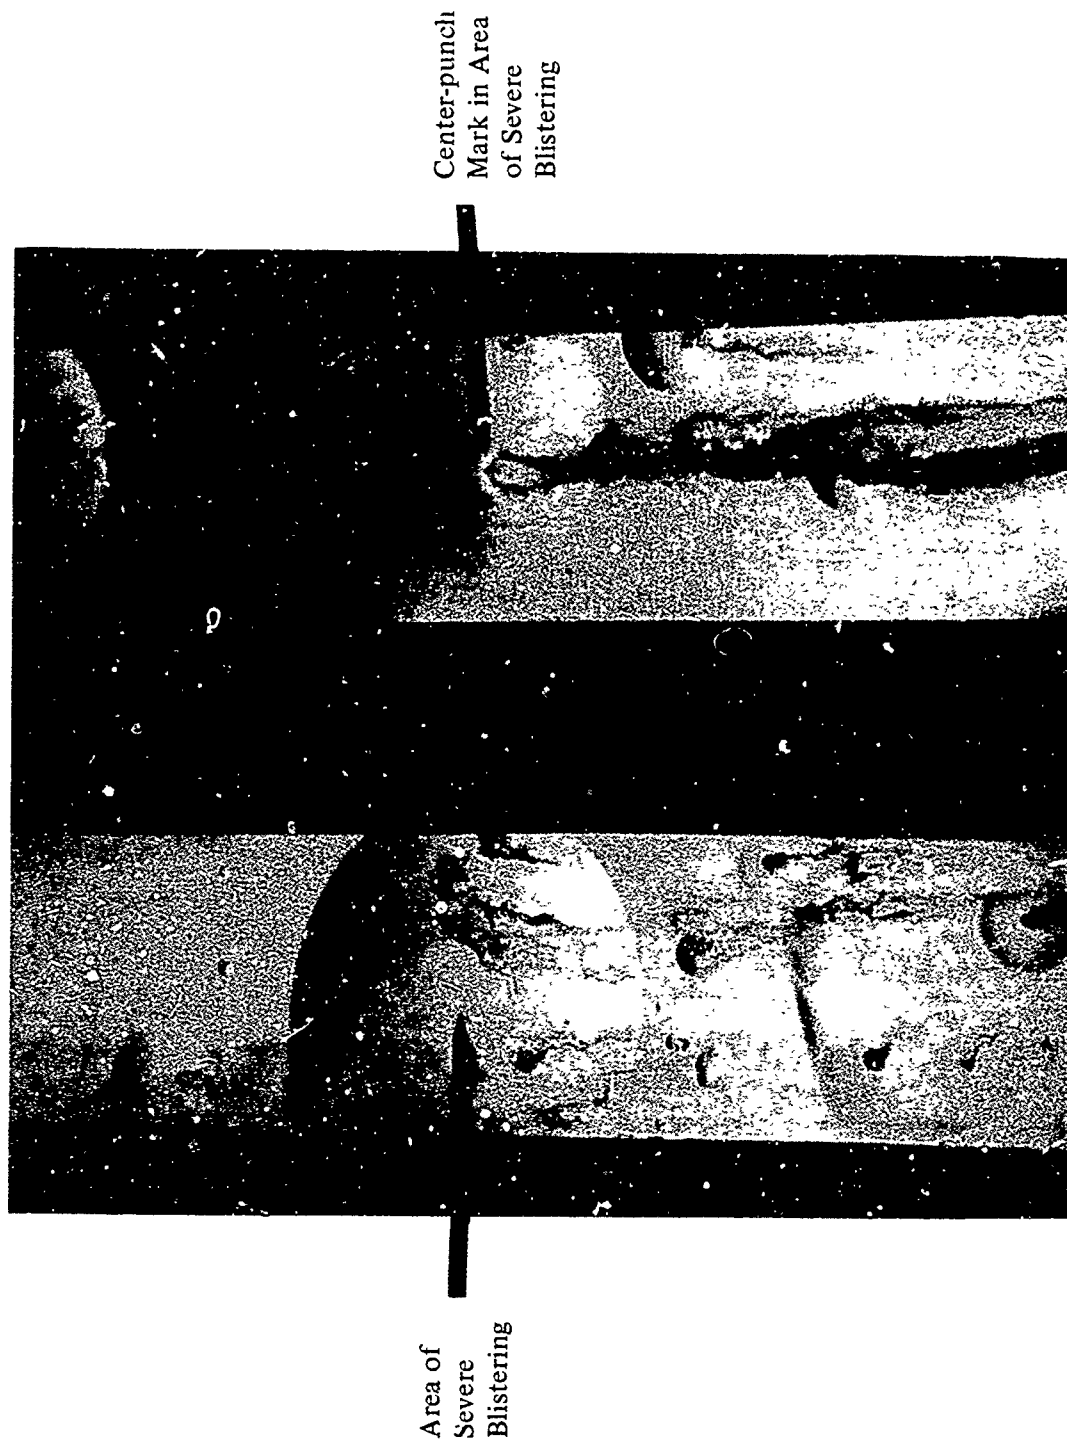
Figure 13. Illustrations of Salt Fog Corrosion Performance of Phosphoric Anodized Aluminum 7075-T651 Test Specimens PR Plated with Zinc (50 amp/ft<sup>2</sup>), Rochelle Copper Struck, and Hard Nickel Plated

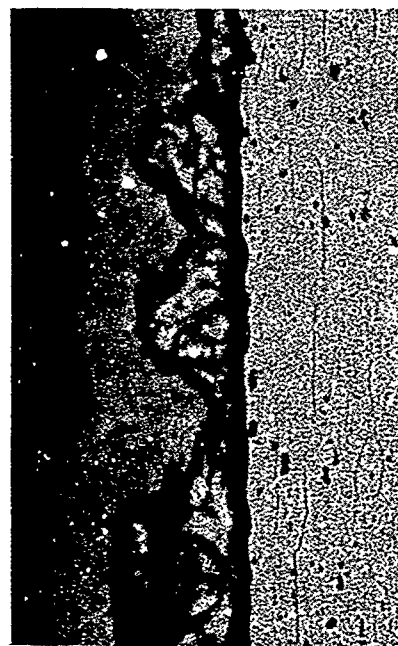
Panel No. 16

Center-punch area showing corrosion of aluminum substrate (above). The adjacent surface exhibits corrosion salts where zinc plate had existed (below).

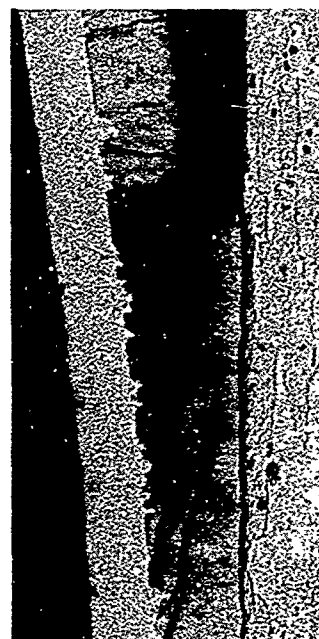
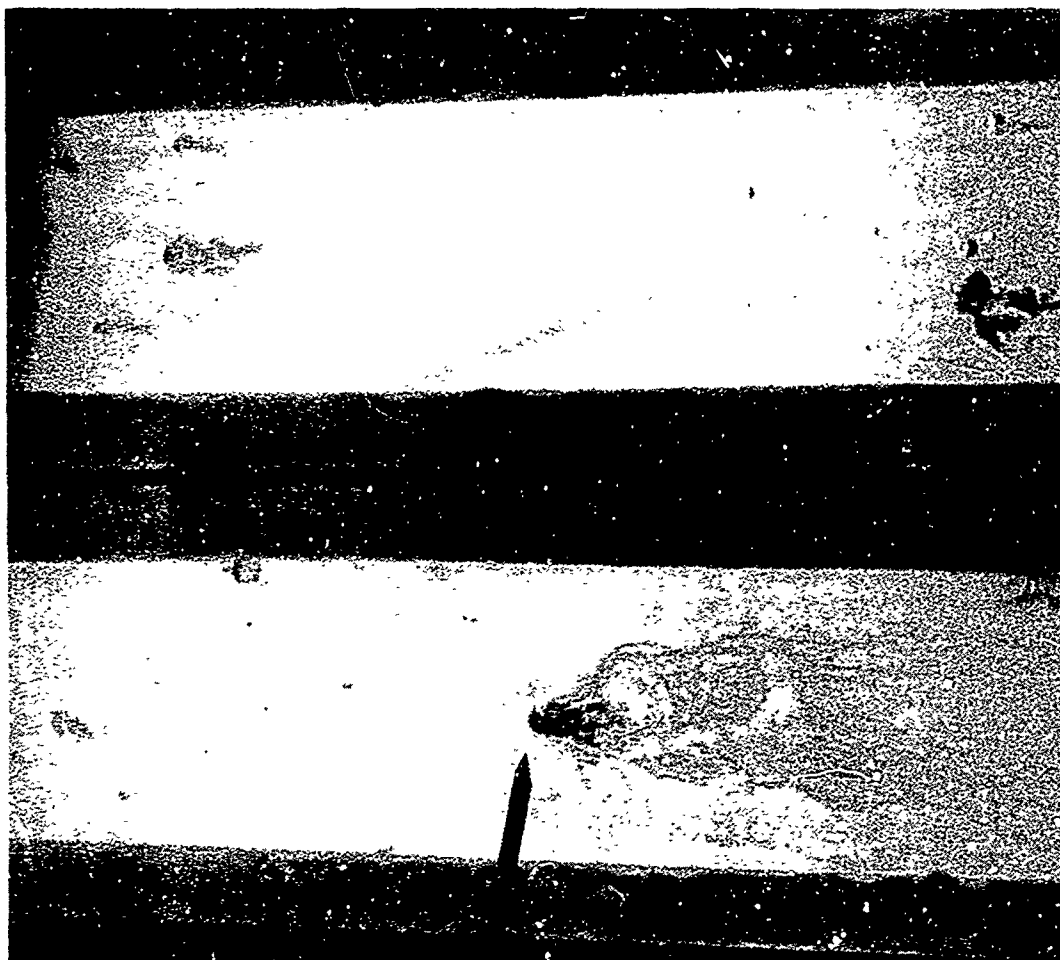
Panel No. 22

Center-punch area shows severe corrosion of the aluminum (above). Area adjacent to center-punch region depicts fracture and lifting of Zn-Ni alloy at zincate surface (below).

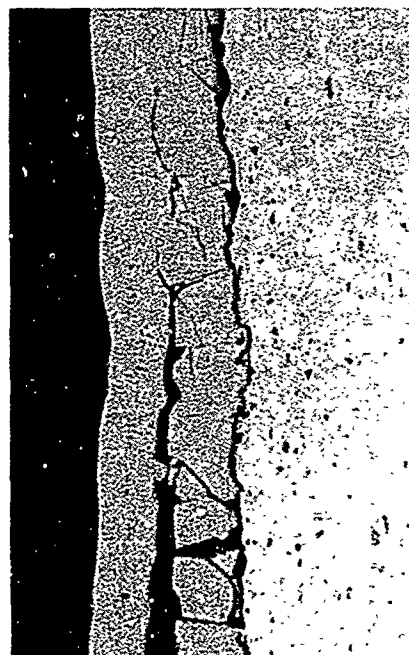
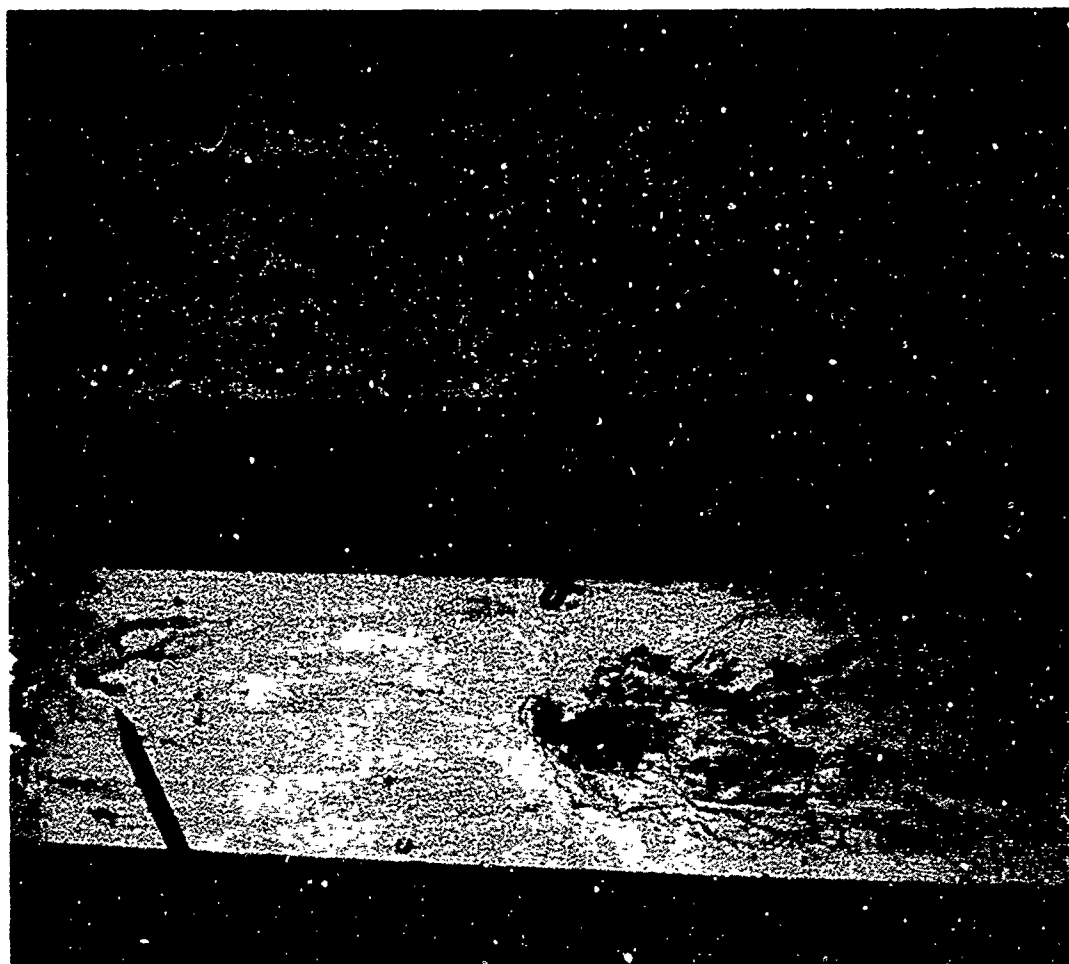
Panel No. 21

View of corrosion pit in aluminum substrate (above). The coating on the edge of the pit showed fragmentation of the Zn-Ni alloy with some separation between the copper strike and the Zn-Ni alloy (below).

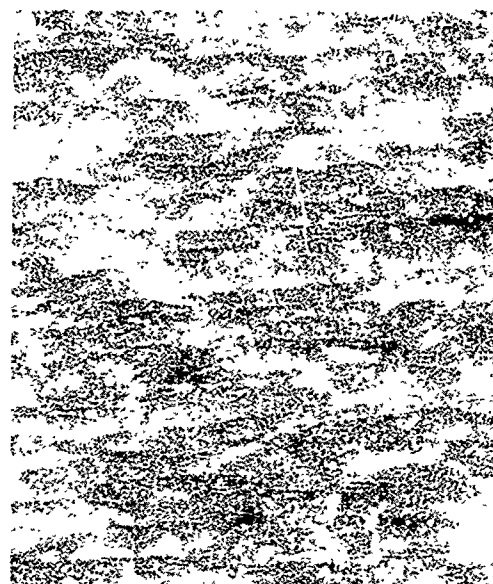
Specimen SP-6

Above photographs show 0.09 mm thick Sanford Plus hard anodized film after 5.0 percent plastic elongation of Aluminum 7075-T651 substrate. All views are normal to anodized surface. Left view employed vertical lighting while view of same surface with oblique lighting is at the right.

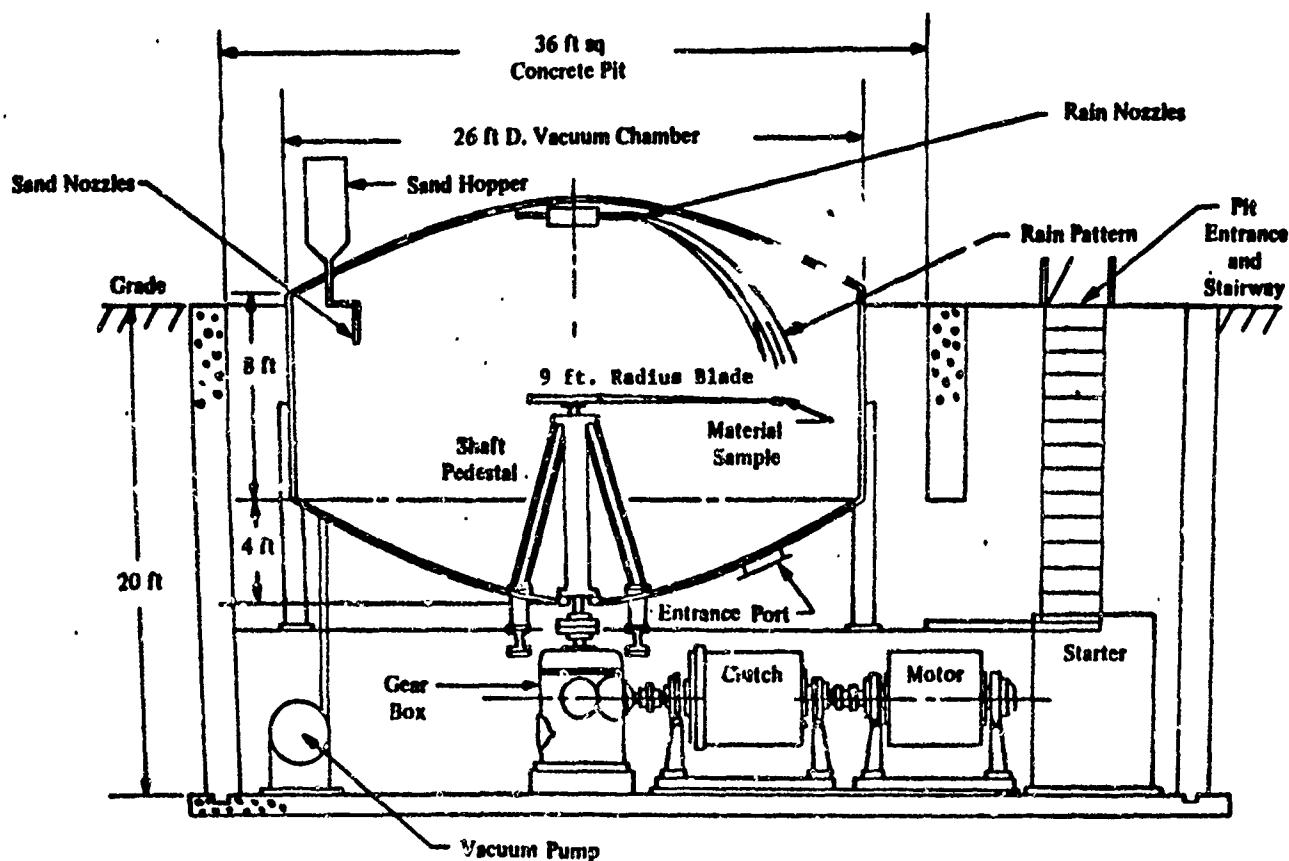
Figure 23. Rain and Particle Erosion Test Facility

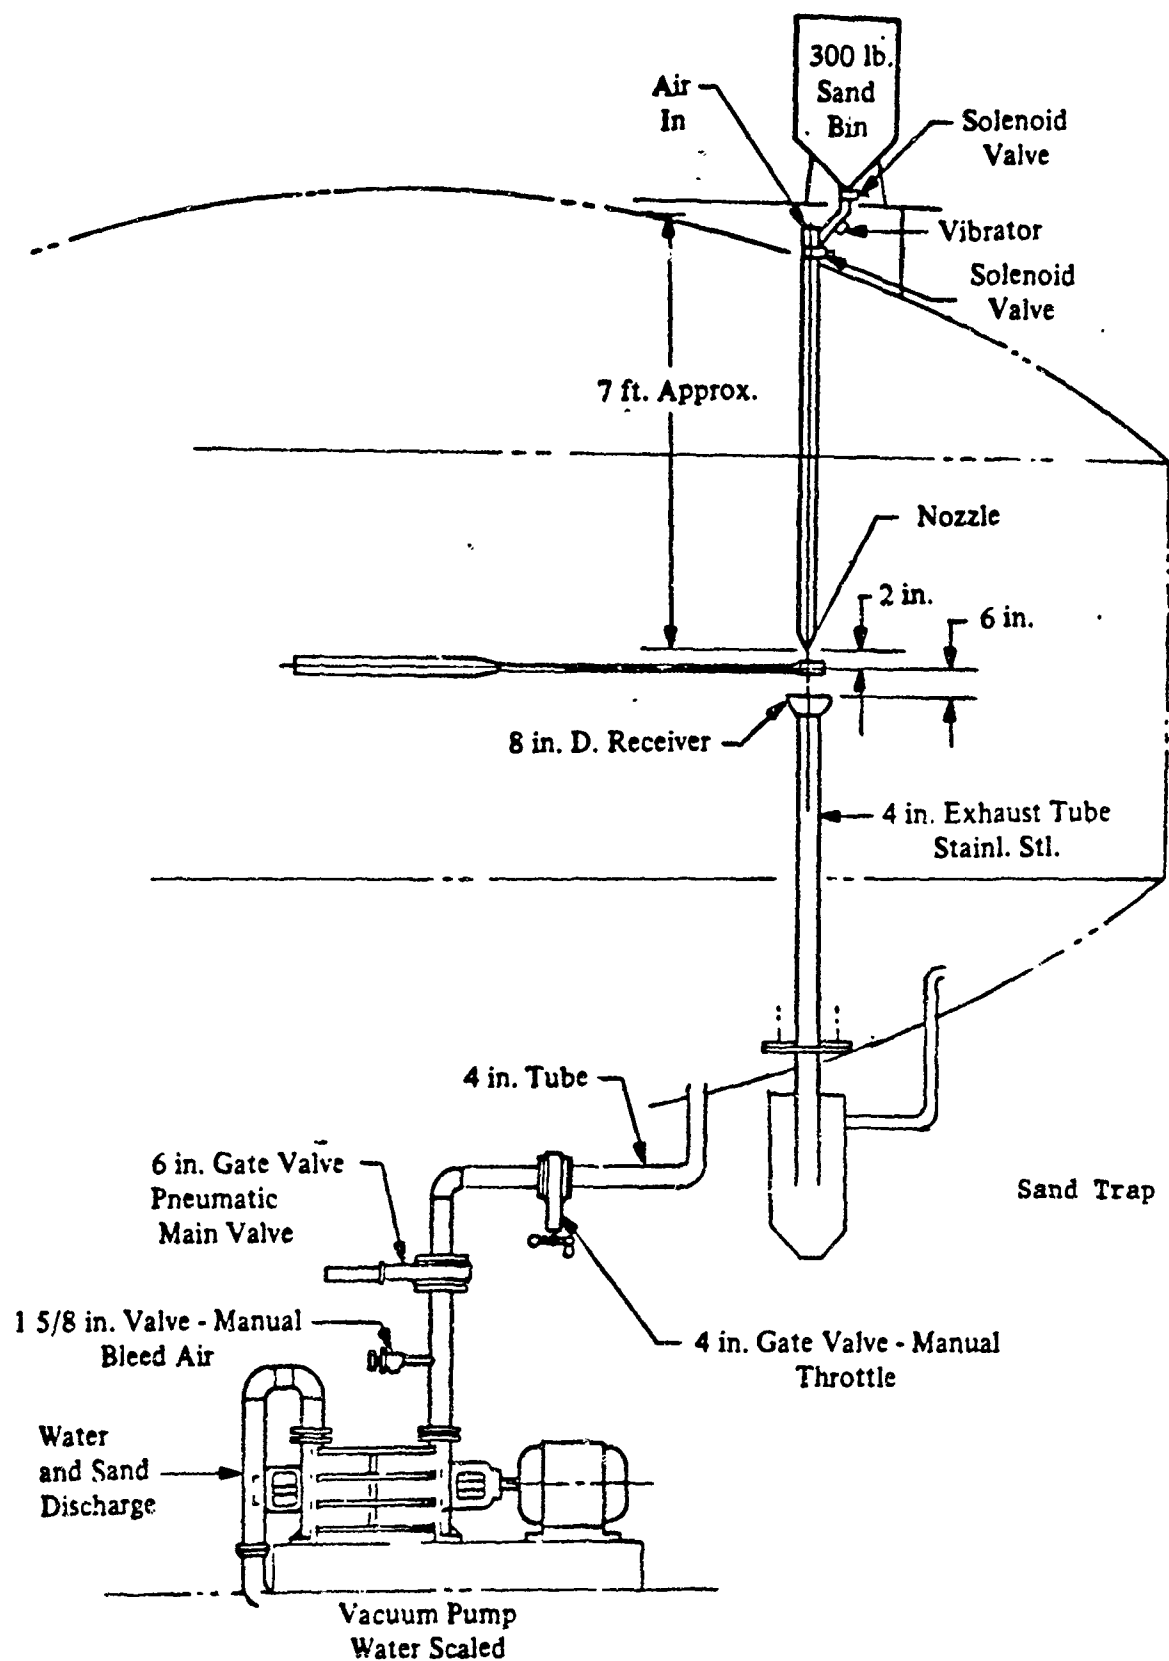
Figure 24. Erosion Test Facility (Sand Erosion Mode)

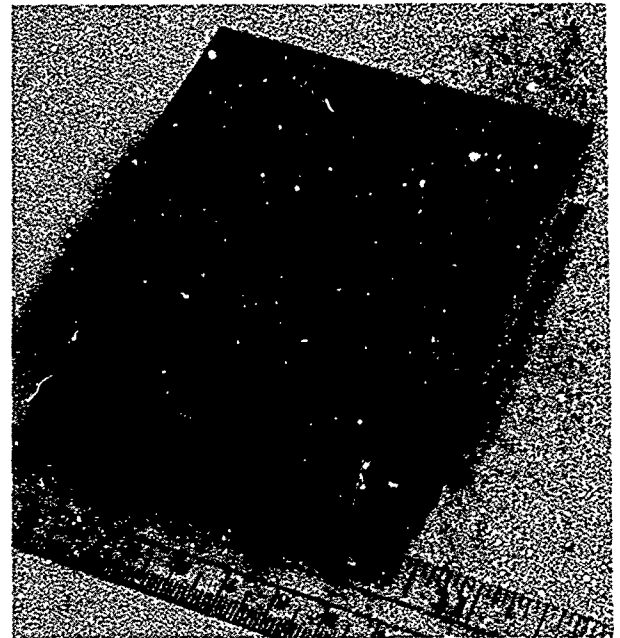
Figure 29. Test Specimen Mounted in Horizontal Plane for Sand Erosion Testing

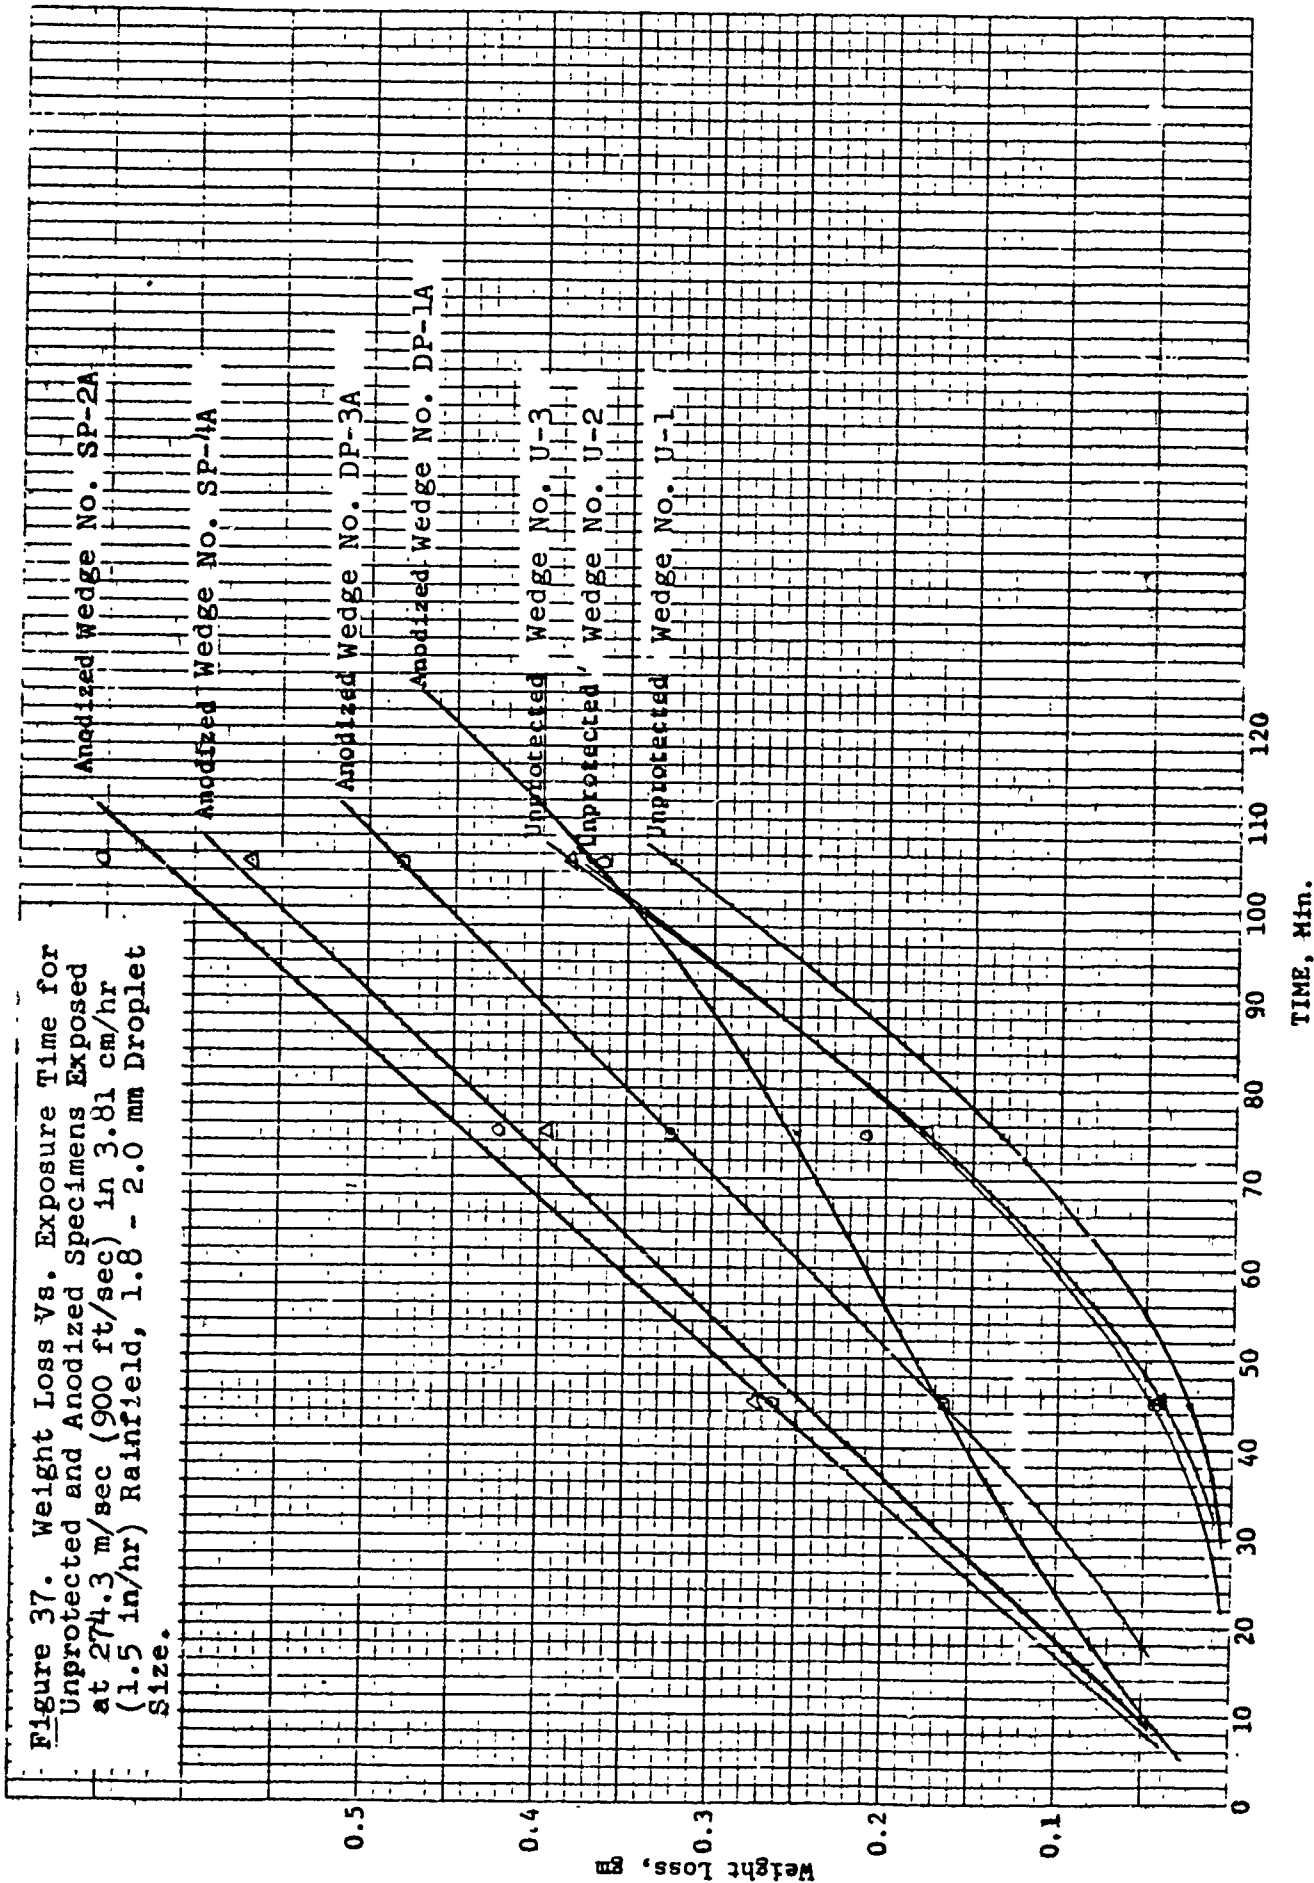
Figure 37. Weight Loss Vs. Exposure Time for Unprotected and Anodized Specimens Exposed at 274.3 m/sec (900 ft/sec) in 3.81 cm/hr (1.5 in/hr) Rainfield, 1.8 - 2.0 mm Droplet Size.

It is noted that erosion of the anodized specimens tends to be linear -- i.e., of a constant rate throughout the test -- whereas the unprotected specimens appear to be unaffected at the beginning of the test, the erosion rate becoming linear only after about seventy-five minutes. It is a characteristic of the water droplet erosion phenomenon that polished metallic surfaces do not show gross erosion until preliminary pitting occurs on a microscopic scale. This initial pitting phase is known as the "incubation period" and is reflected in the early stages of the erosion curves for the unprotected specimens in Figure 37. Once the incubation period is complete, the erosion rate becomes linear.

Examination of Figure 37 shows that the performance of all of the anodized specimens was, to various degrees, worse than that of the unprotected specimens.

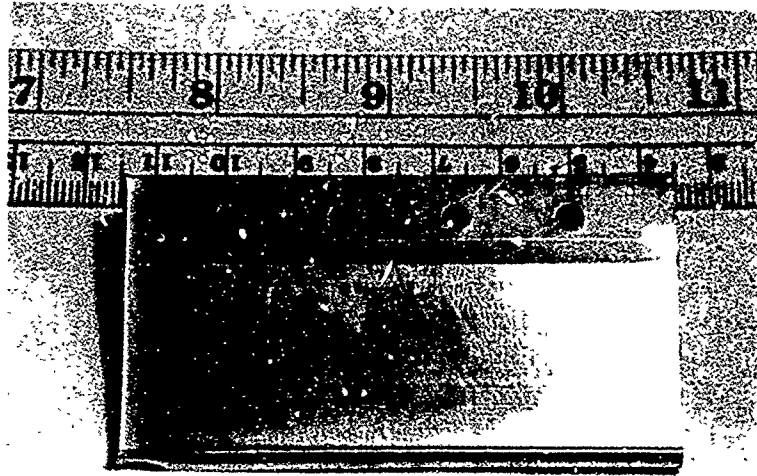
Figure 40. Wedge Number N-2A Processed by Phosphoric Acid Anodizing, Low pH Nickel Plating, and Hard Nickel Plating at  $1.86 \text{ amp/dm}^2$  ( $20 \text{ amp/ft}^2$ ) for 24 Hours. Before Test

Nickel plated specimens N-1A, N-2A, N-3A, and N-4A are shown prior to testing in Figures 38, 40, 42, and 44, respectively. The same specimens are shown after seven hours of exposure in Figures 39, 41, 43, and 45. Figure 42 shows the thickening of the plated surface toward one end of Wedge Number N-3A. High current density nodule growth and surface imperfections were associated with this thickening. Erosion of this specimen in the thickened area is evident in Figure 43. A similar phenomenon was observed to a lesser degree in Wedge Number N-4A shown in Figures 44 and 45. Erosion rate of this specimen was somewhat higher than that of Wedge Numbers N-1A and N-2A which exhibited more uniform finish. Inherent roughness from the zinc-nickel alloy plate applied to Wedge Number N-4A evidently influenced the finish obtained on the hard nickel outer plate. Figures 46 and 47 show edge views of eroded Wedge Numbers N-3A and N-4A where the eroded areas are clearly visible. From Figure 46 it appears that nickel plating growth exceeded the designed shield

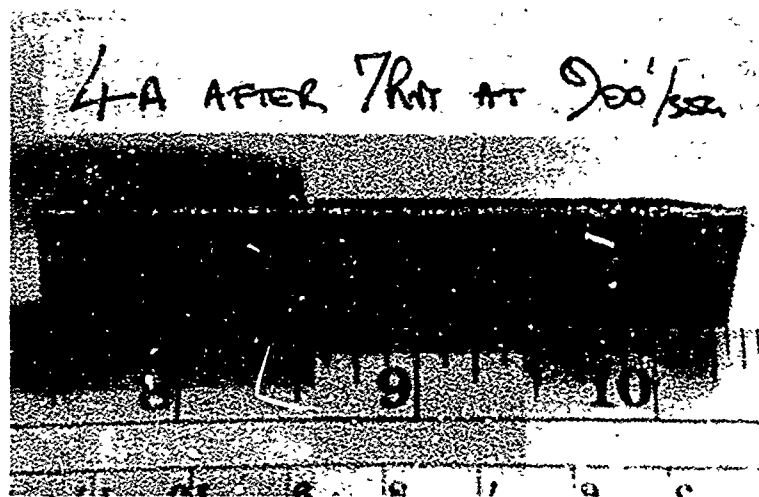
Figure 47. Hard Nickel Plated Wedge Number N-4A Showing Moderate Erosion of the Leading Edge Associated with Nodule Growth and Surface Imperfections (After Testing)

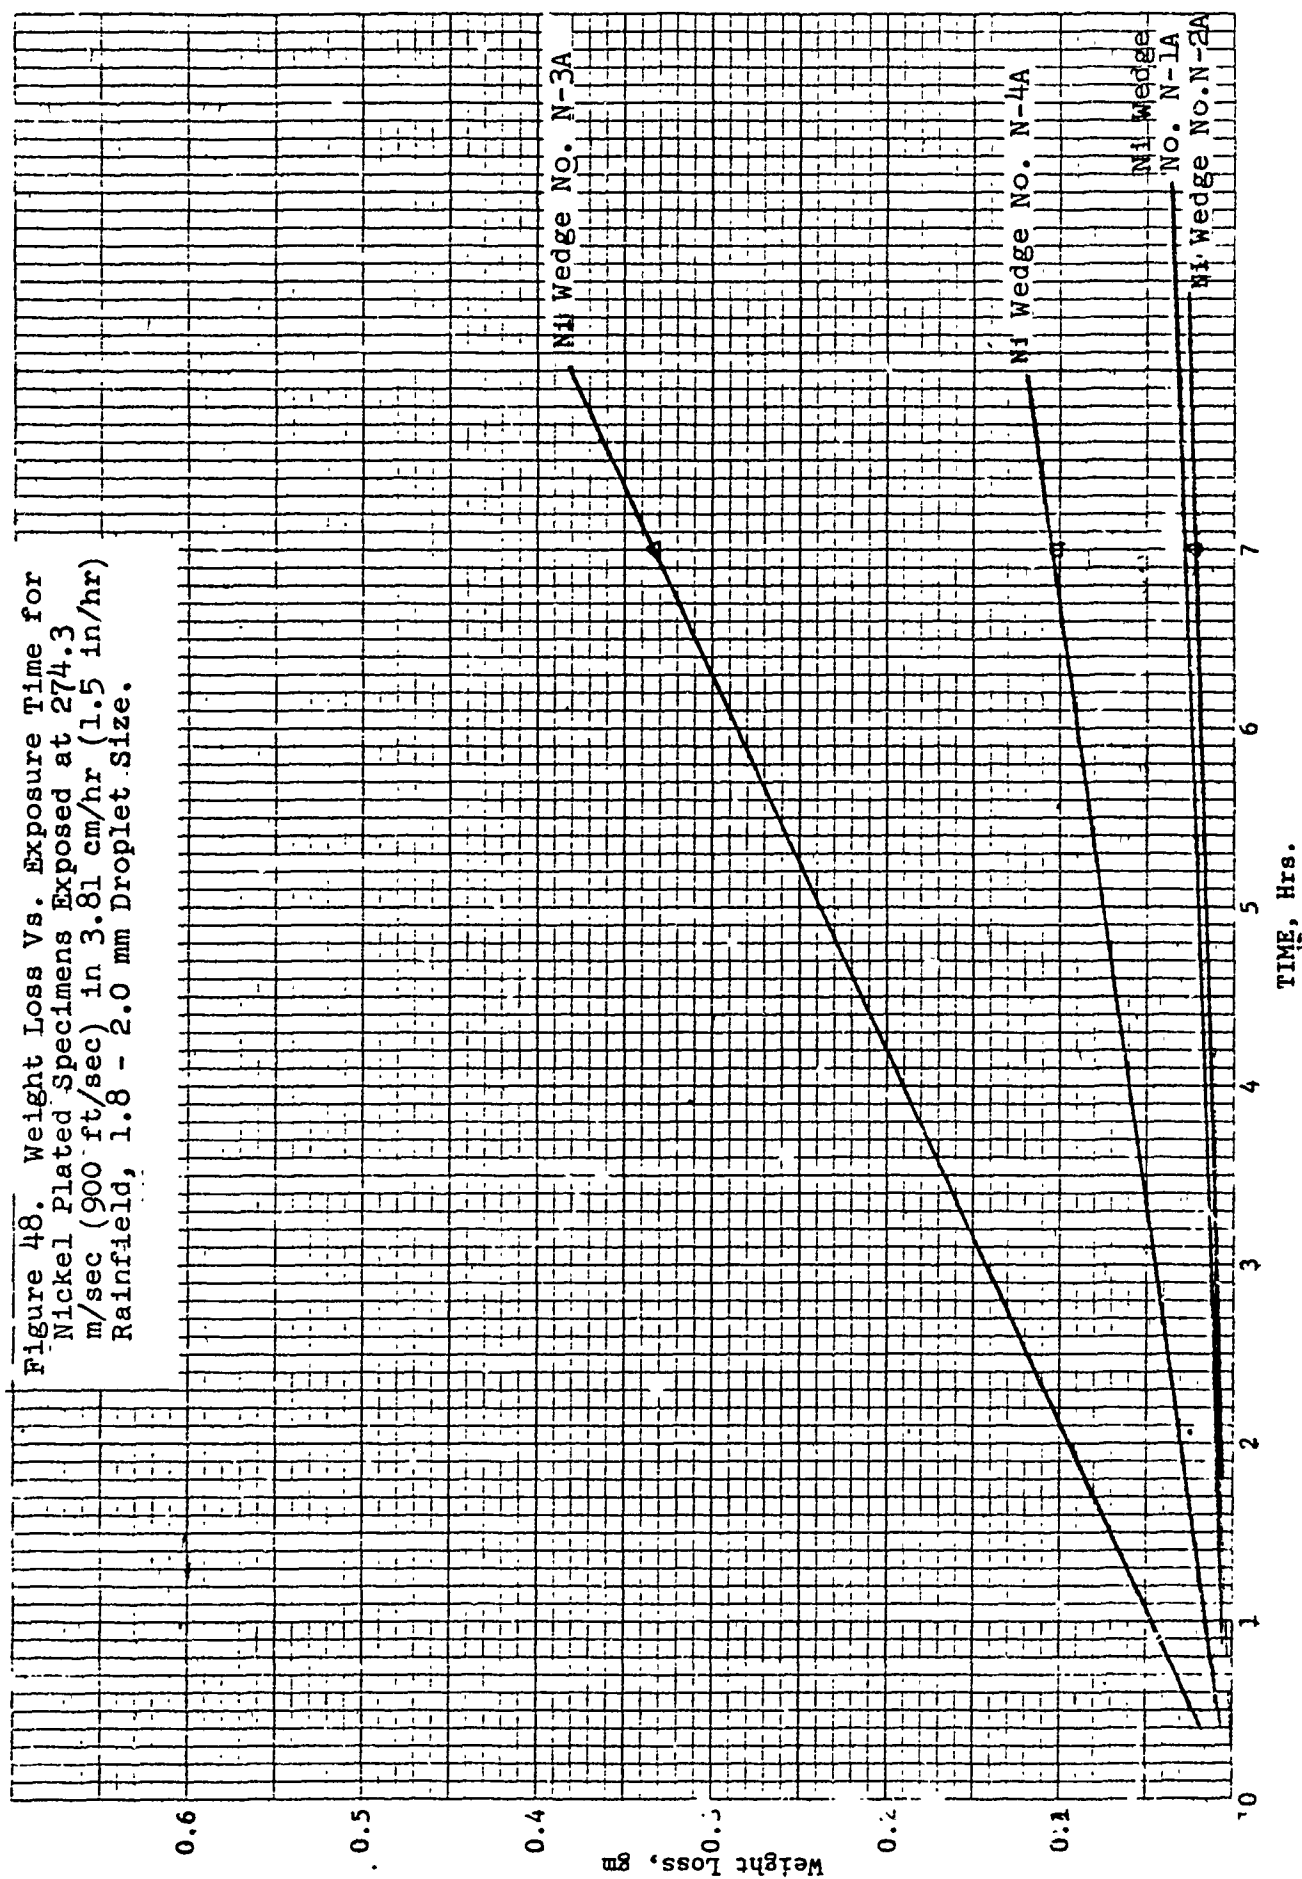
Figure 48. Weight Loss Vs. Exposure Time for Nickel Plated Specimens Exposed at 274.3 m/sec (900 ft/sec) in 3.81 cm/hr (1.5 in/hr) Rainfield, 1.8 - 2.0 mm Droplet Size.

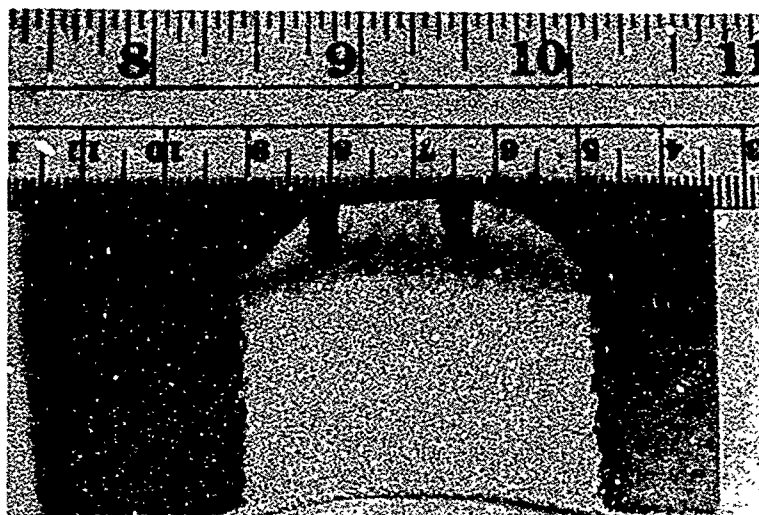
Figure 52. Duranodic Anodized (0.09 mm) + Sandstrom LC-300 Specimen after Exposure for 60 Minutes at 274.3 m/sec (900 ft/sec) to Sand Environment; Sand Flow 908 g/min (2 lb/min)
